Revision Date - 09/24/2021

FACILITY CONDITION ASSESSMENT

Druid Hills High School | 2021

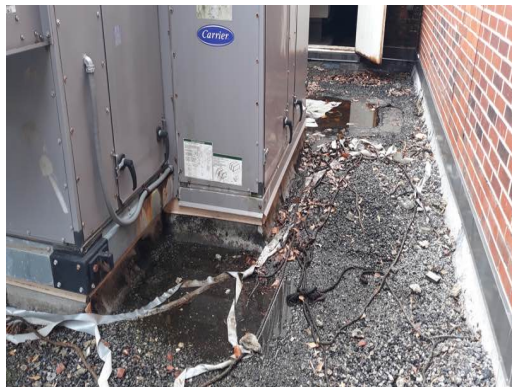
| Deficiency | Category | Qty | UoM | Priority | Repair Cost | ID |
|---|---|---|---|---|---|---|
| Note: Beyond Useful Life - Low Roof. Built Up Roofing Over Mod. Bit Roof Both Assemblies Need To Be Replaced | | | | | | |

Built-Up Roofing Over Original Modified Bitumen Roofing Are Beyond Useful Life And Need To Be Replaced

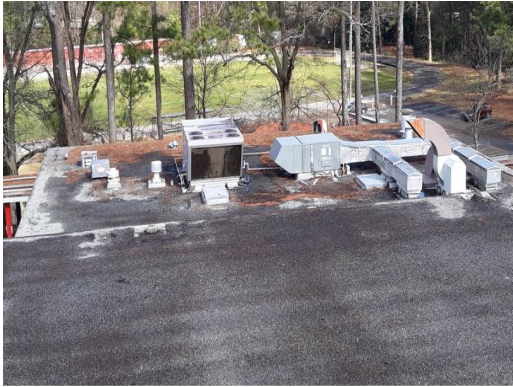
Built-Up Roofing Is Beyond Useful Life And Needs Replacement

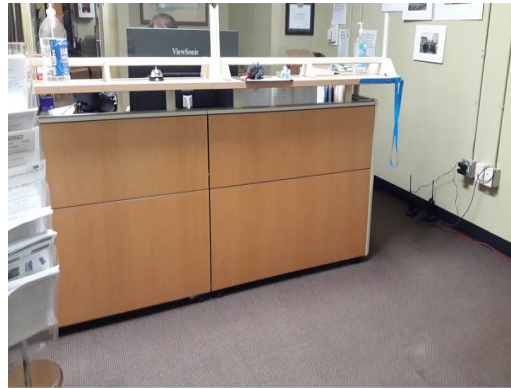
Main Office Reception Counter Is Non-ADA Compliant And Needs Retrofit To Make ADA Compliant

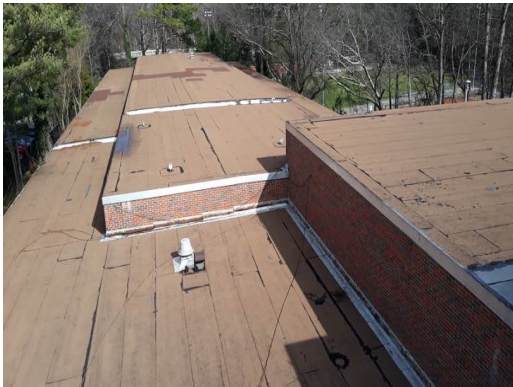
Modified Bitumen Roofing Beyond Useful Life Needs Replacement

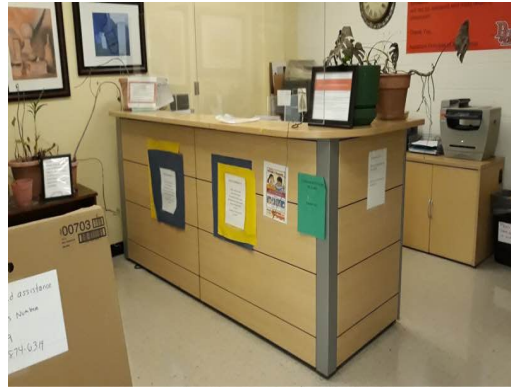
Administrative Office Counter Is Non-ADA Compliant. Counter Needs To Be Retrofitted To Make ADA Compliant

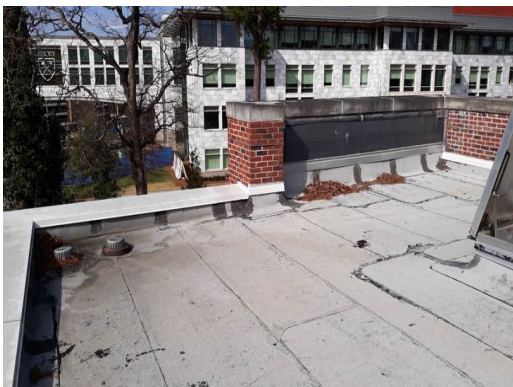
Debris Throughout Roof And At Roof Drains Need To Be Cleaned
